CALSPAN ON-SITE AIR BAG DEPLOYMENT INVESTIGATION

CALSPAN CASE NO. 93-8

VEHICLE #1 - 1991 CHEVROLET CORSICA LT (AIR BAG-EQUIPPED)

CRASH DATE - [REDACTED], 1992

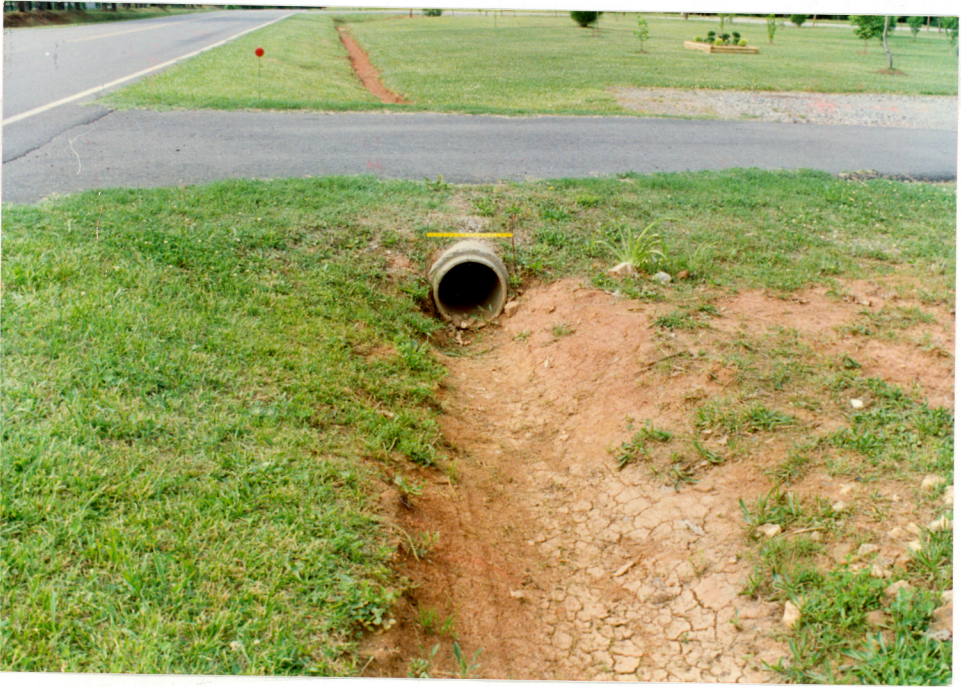
9. View of driveway culvert along ditch line.

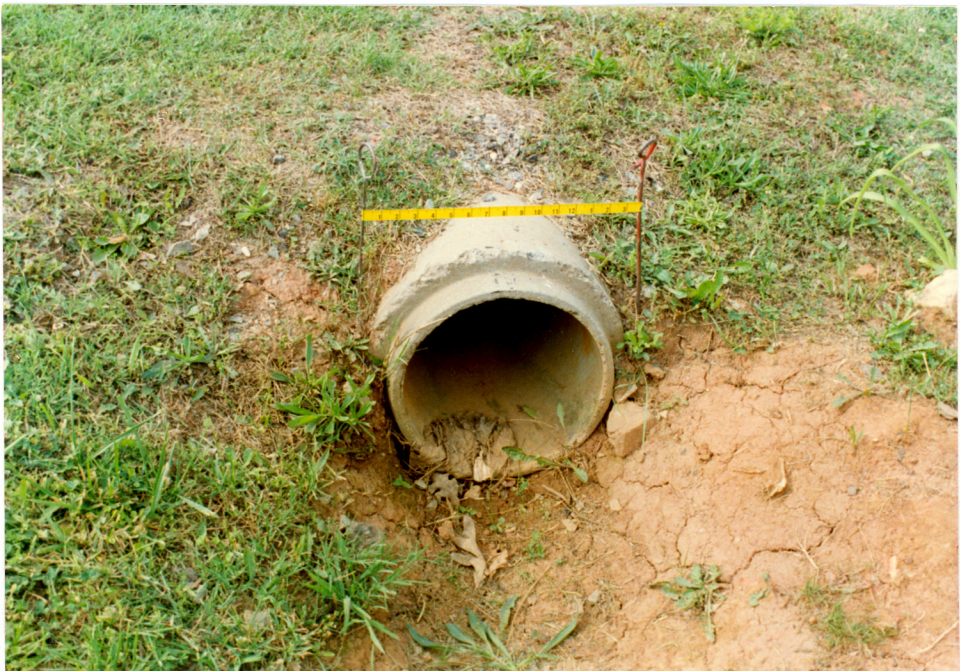
10. View of driveway culvert at the POI.

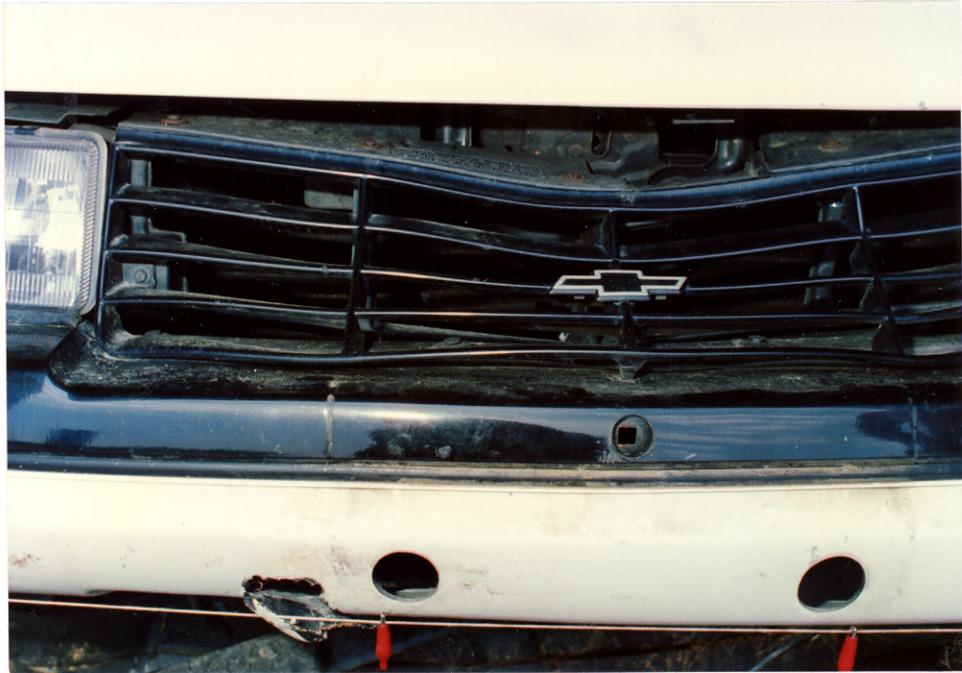
Components damaged in the crash included the front bumper, lower valence/air dam, radiator support bracket, radiator, both frame rails, grille panel, and windshield. The engine frame rails were displaced rearward with the right rail moved 11.4 cm (4.5") rearward and the left rail 2.5 cm (1.0") rearward. The right wheelbase was reduced by 2.3 cm (0.9"). The front bumper energy absorption devices (EAD) compressed during the crash with 1.6 cm (0.6") of stroke noted on the right side and 1.0 cm (0.4") of stroke on the left side. Both EADs returned to full restitution at 11.4 cm (4.5").

25. View of the center grille area and front bumper.

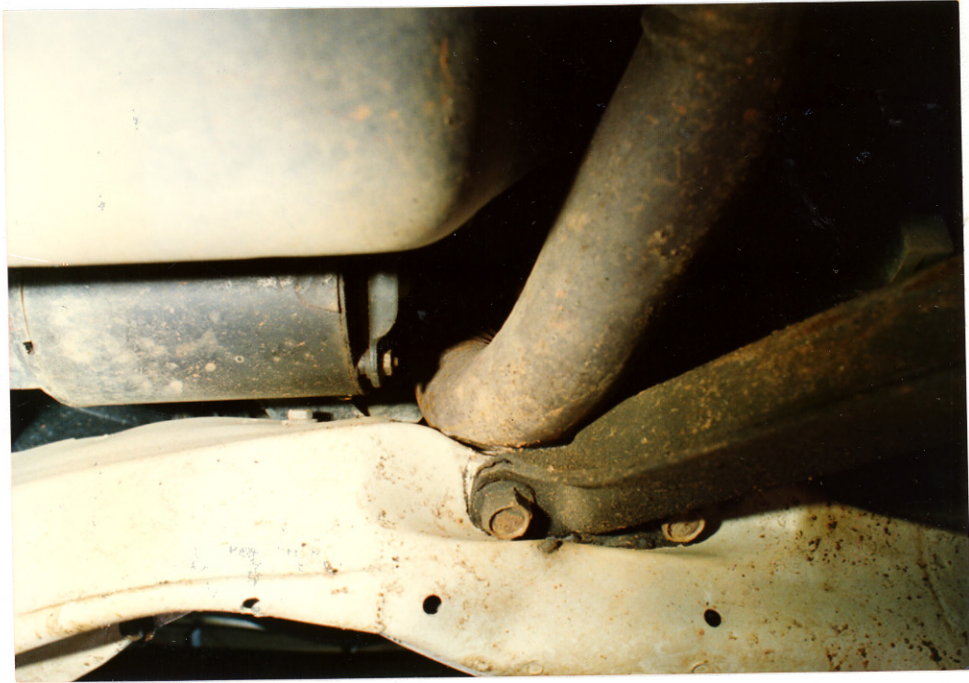
31. Close-up view of leading edge of right front frame rail.

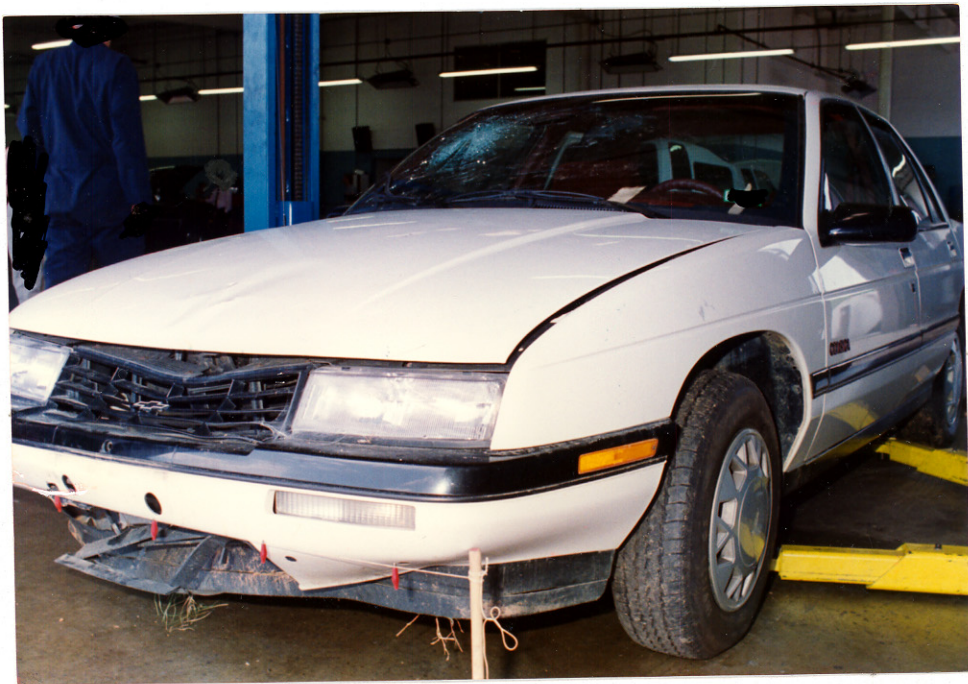
34. Left front corner view showing impact damage.

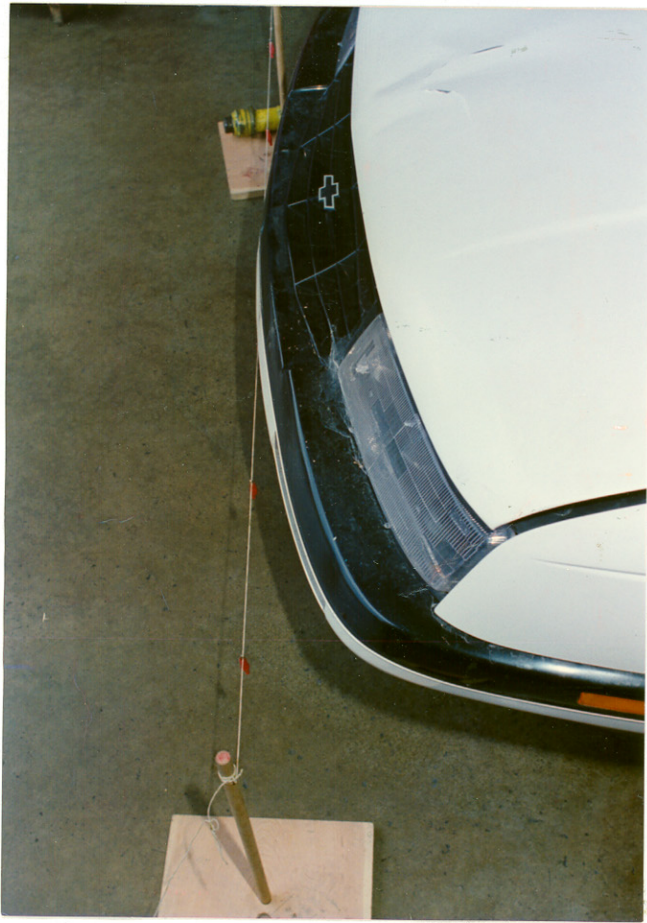
36. Lateral view from right to left of the front bumper showing minimum rearward displacement.

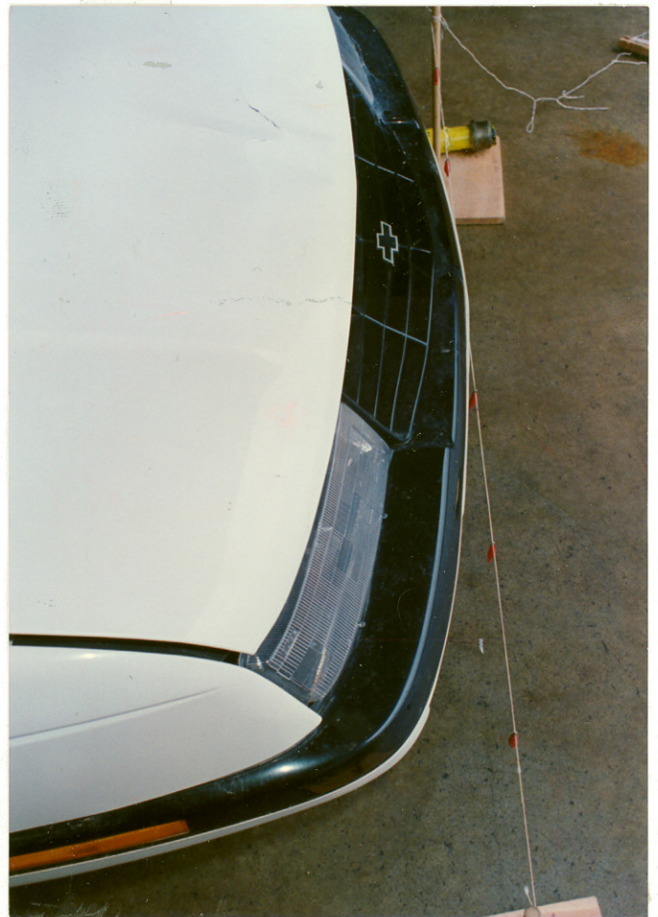
35. Lateral view from left to right of the front bumper showing minimum rearward displacement.

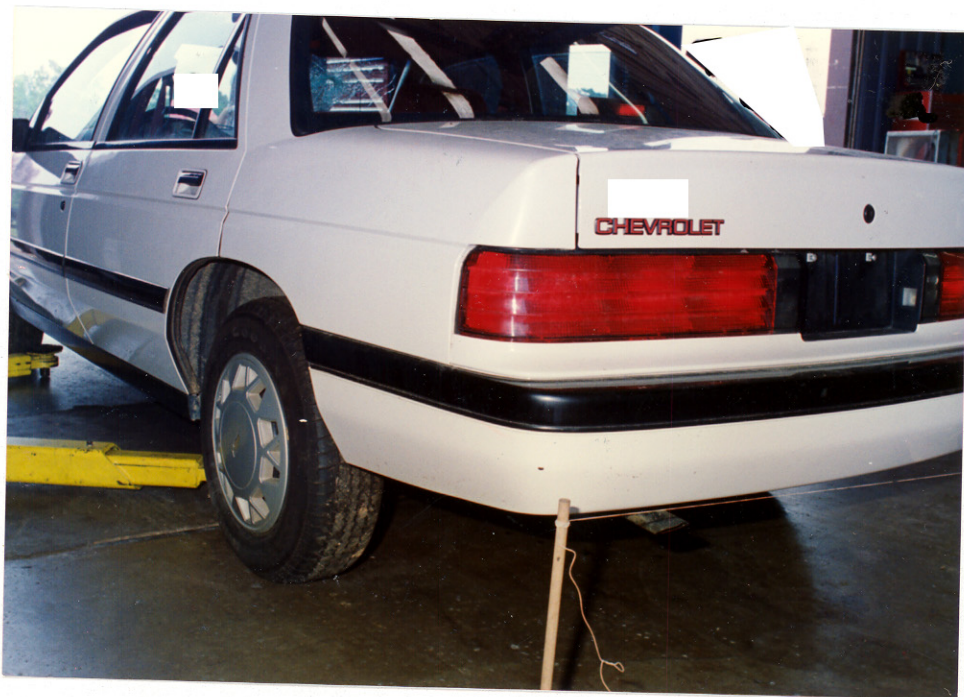
38. Left rear corner view verifying no side or rear crash damage.

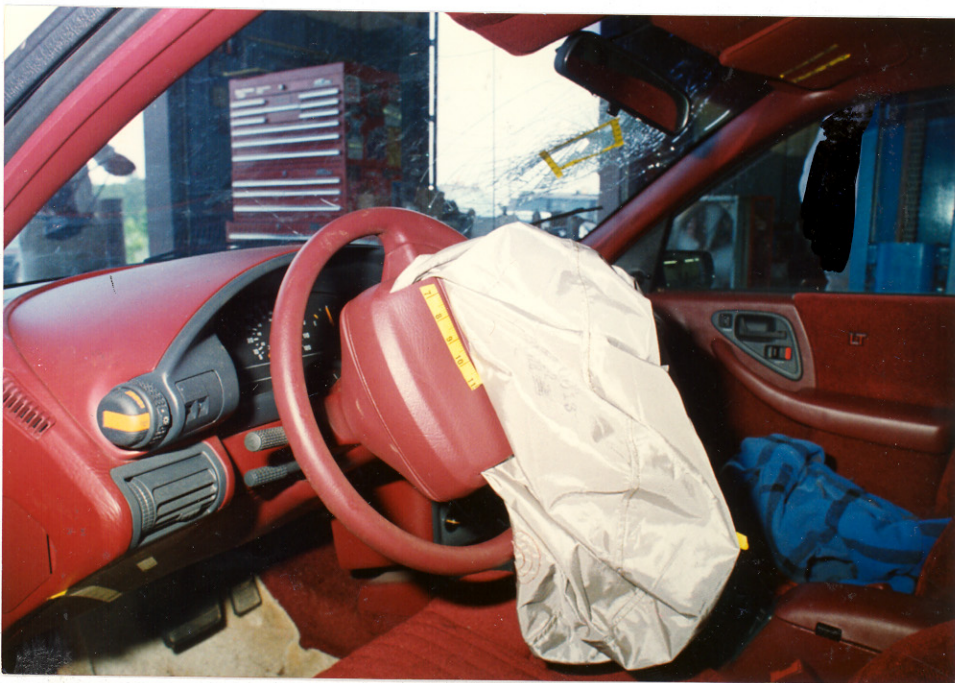
Interior damage to the Chevrolet Corsica LT was associated with air bag deployment and occupant contacts. The air bag module cover opened along the designed seam lines in the typical "H" pattern configuration. A tissue transfer was noted on the upper flap along the horizontal parting seam line which began at the lower right corner and extended laterally 7.6 cm (3.0") to the left (refer to photograph #46 and slide #43). The manufacturer's insignia on the lower flap was located 3.2 cm (1.25") down from the upper right corner of the flap and 4.1 cm (1.6") left of the right vertical seam. Hair fibers associated with the driver's hair were wedged in the bottom corner of the insignia.

42. Angular view of instrument panel and deployed air bag.

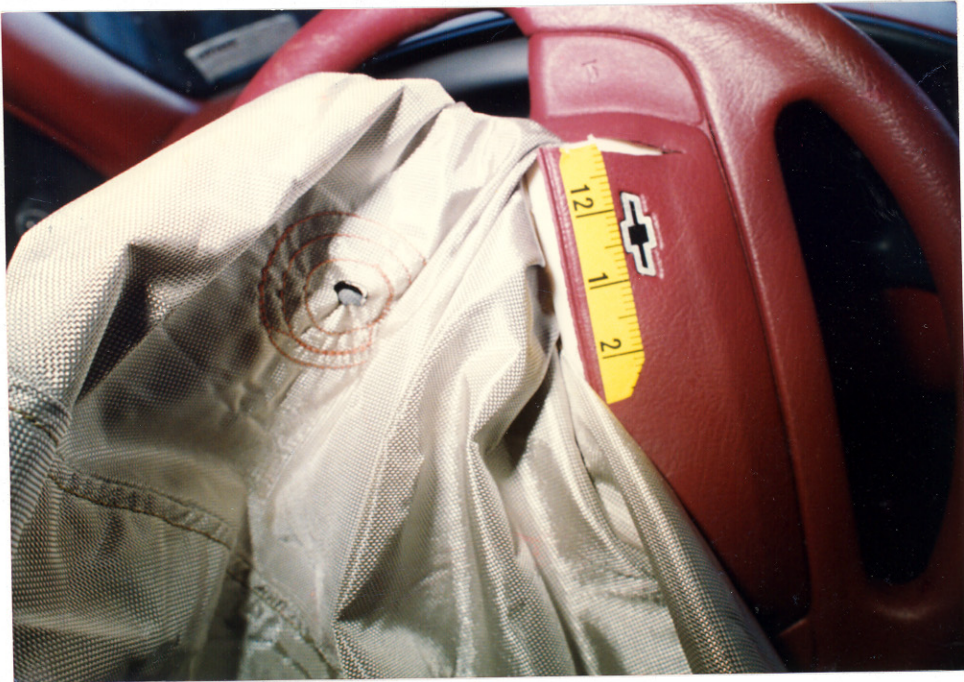
A tissue transfer located along the lateral seam line of the upper module flap began at the bottom right corner and extended 7.6 cm (3") to the left. This was attributed to contact with the driver's neck during the air bag deployment sequence. Strands of hair associated with the driver's head were observed wedged in the lower right corner of the Chevrolet insignia. This was attributed to contact by the lower flap during the deployment sequence.

45. View of the lower air bag module flap and vent port.

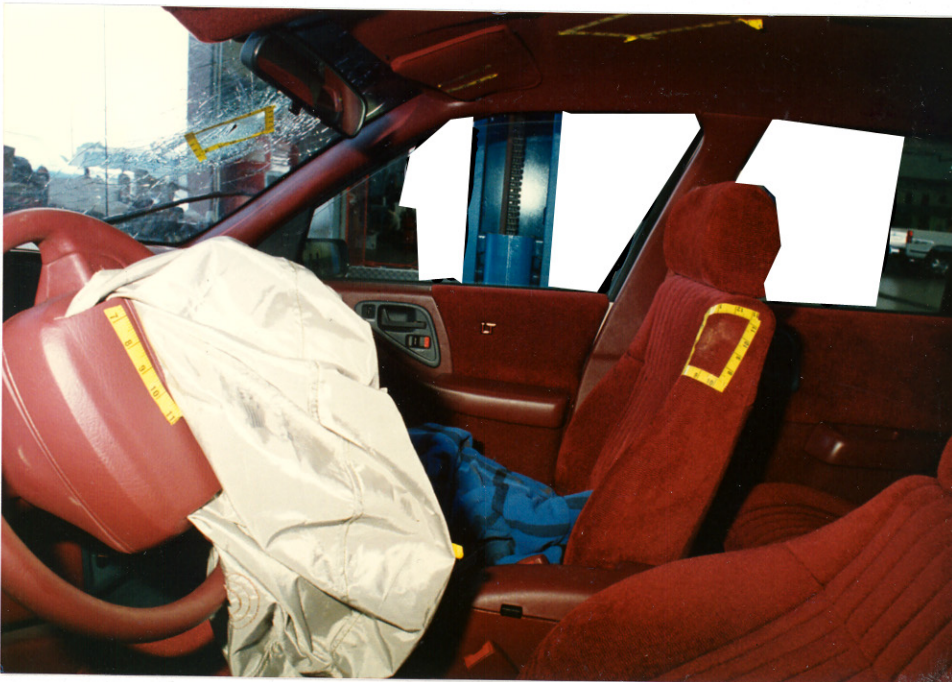
A smudge mark attributed to the passenger's upper torso was noted on the upper edge of the mid-instrument panel below the windshield. A bodily fluid transfer on the right sunvisor located 36.6 cm (14") right of the centerline was attributed to post-impact contact by the right front passenger. She was described by witnesses as covered with bodily fluid and found in the rear seat area.

54. Lateral view of front seats from the left side showing emesis on the console side of the right front seat back rest.

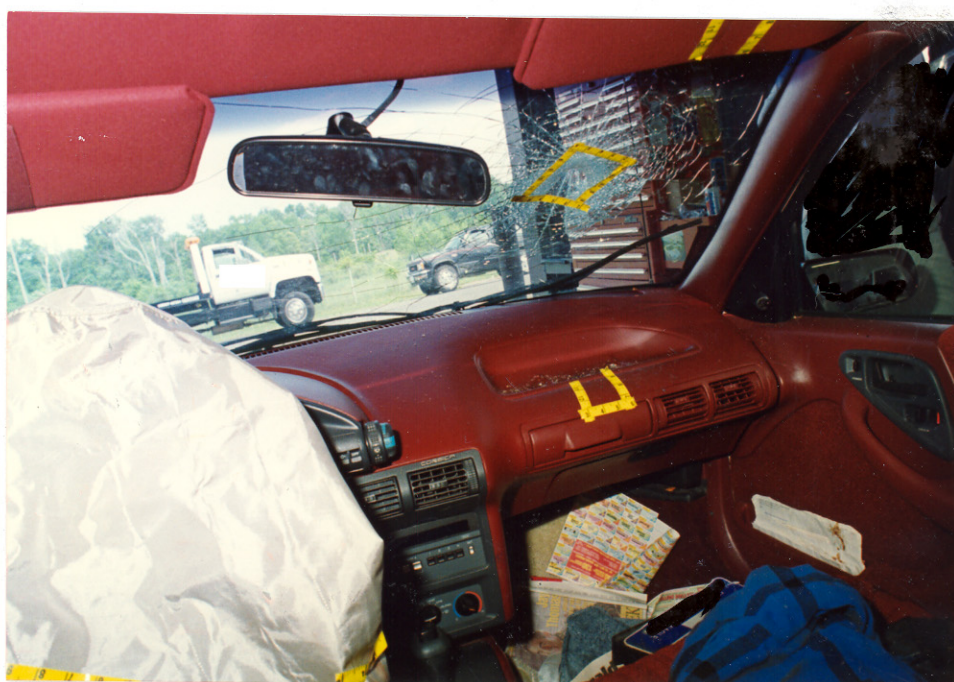
56. View of right front instrument panel and windshield.
